#### National Register of Historic Places Registration Form

1. Name of Property	
historic name West Denton Warehouse/Wharf	
other names CAR- 311	
2. Location	
street & number 10215 River Landing Road	not for publication
city or town West Denton	vicinity
state MD code MD County Carolin	e code011 zip code21629

#### DESCRIPTION SUMMARY:

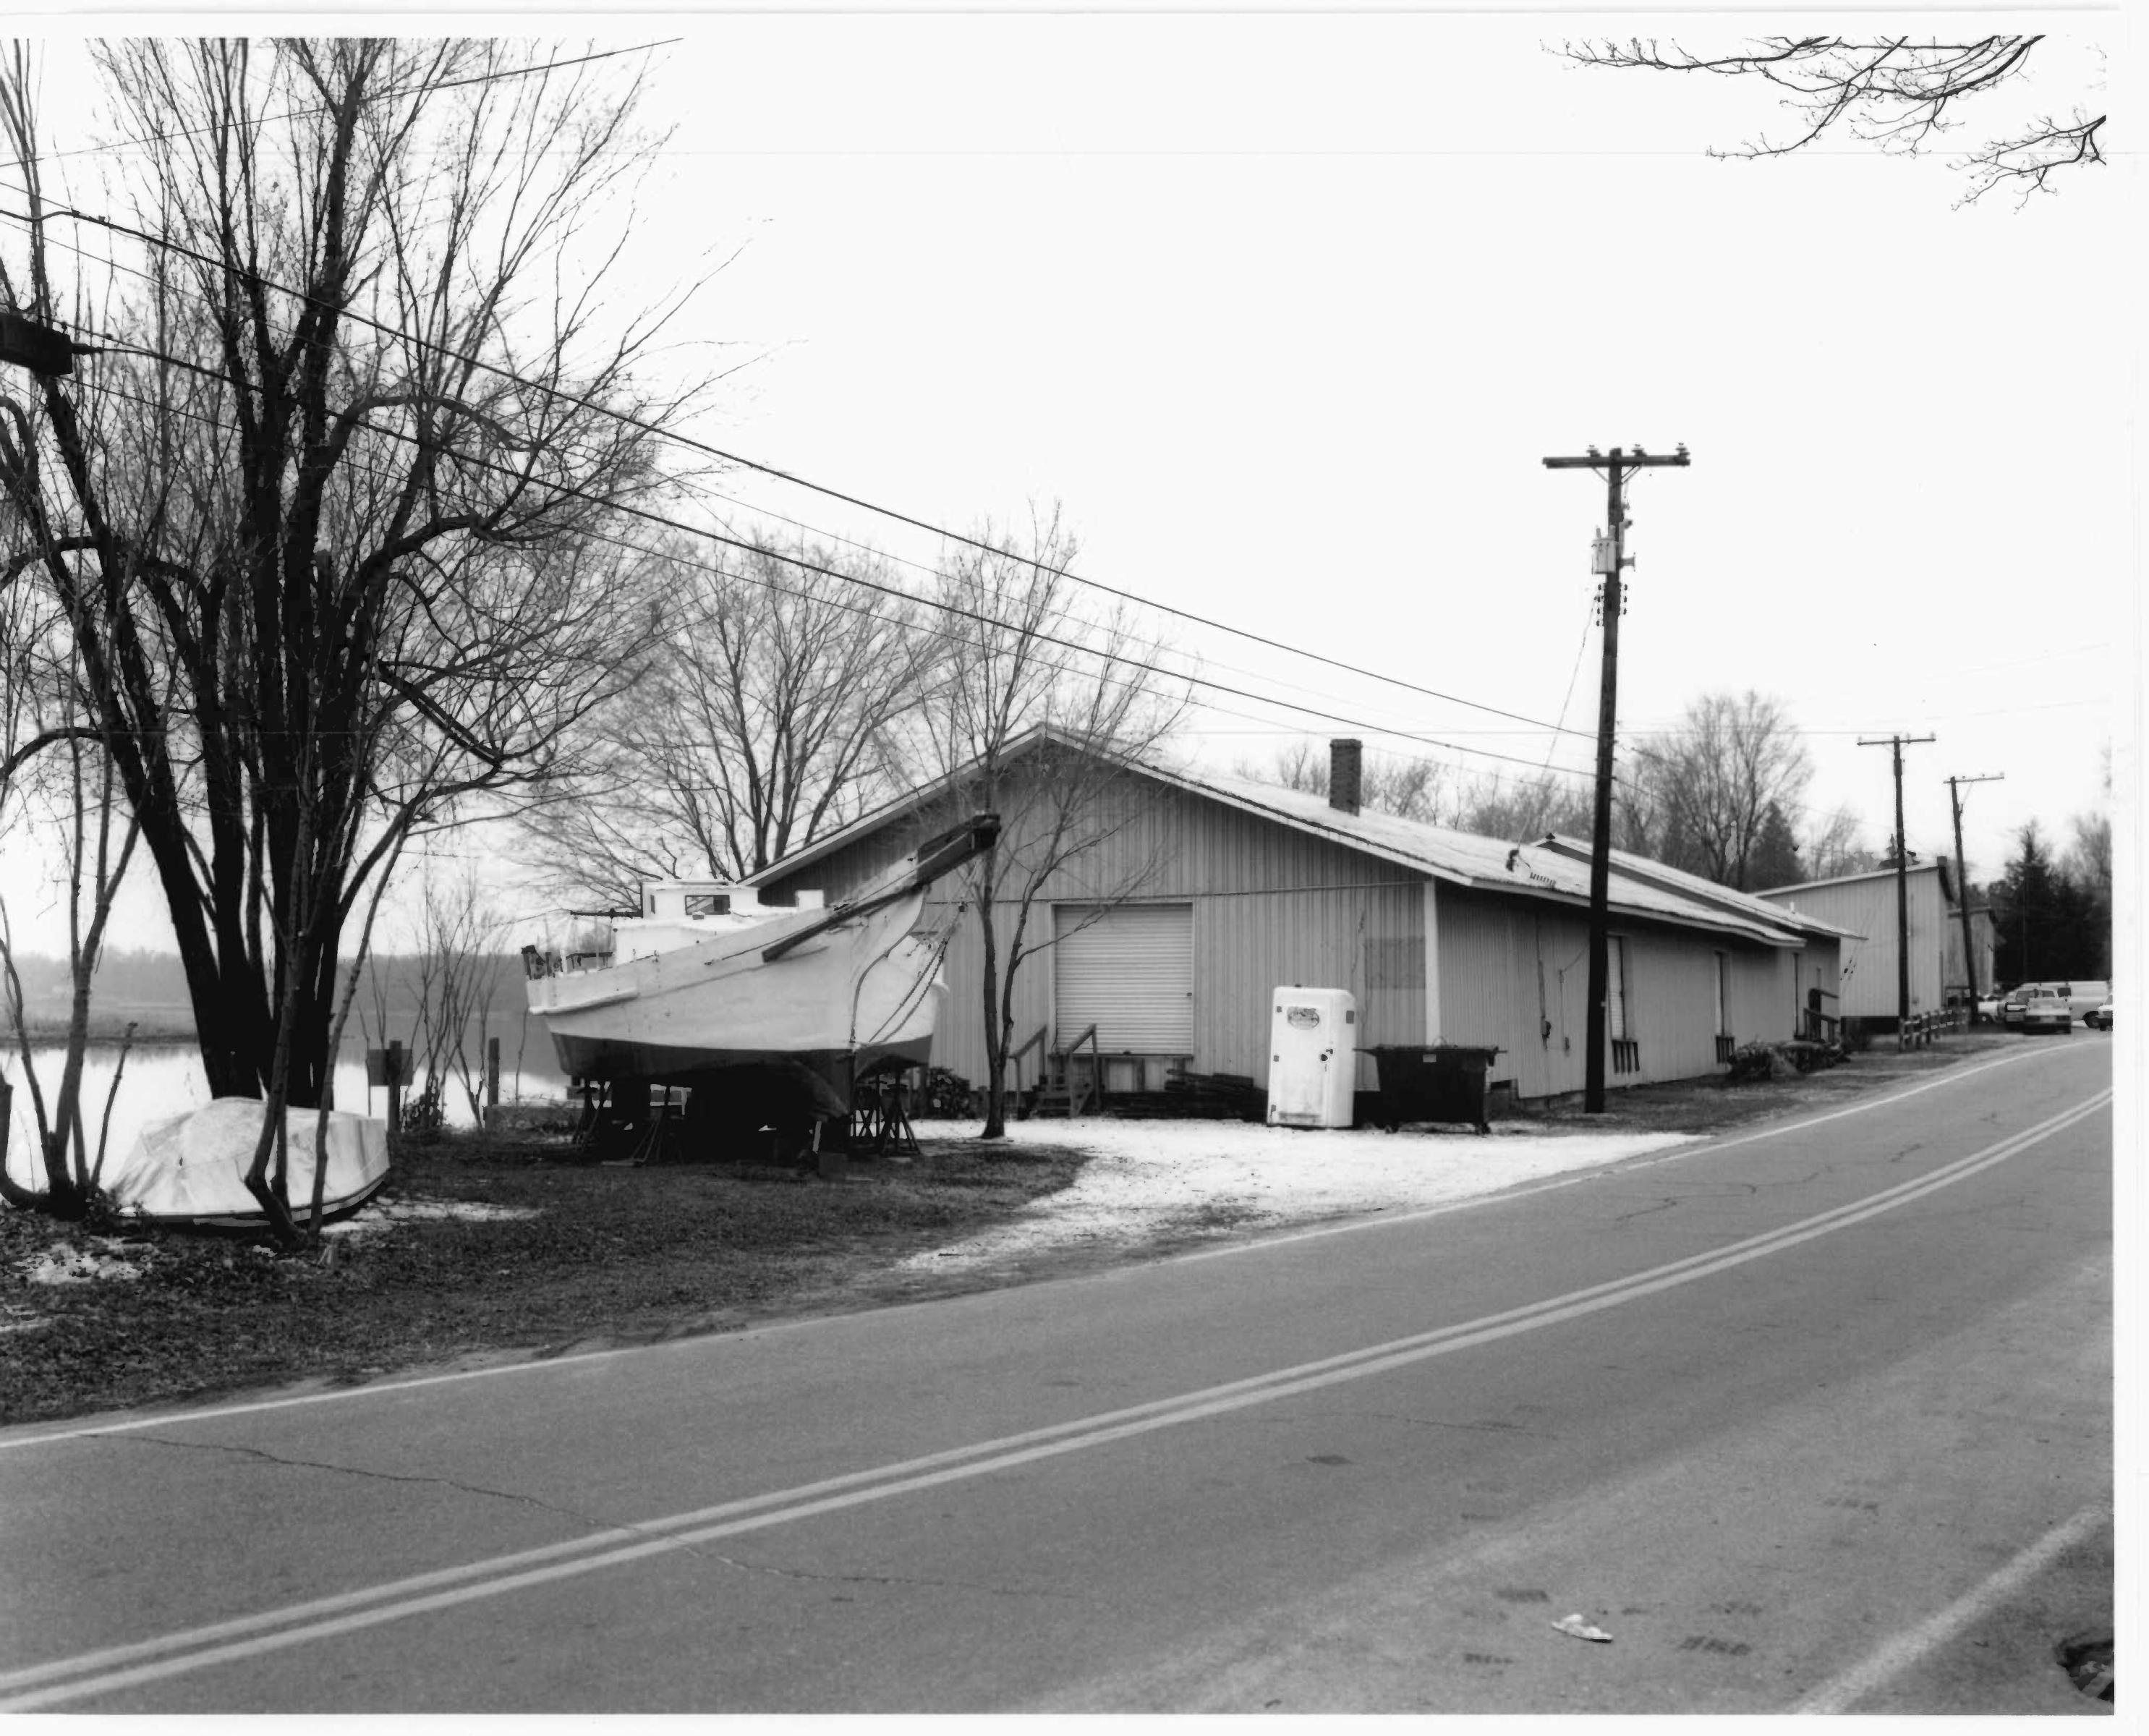
Description - North elevation (partial west elevation) with skipjack (F.C. Lewis, Jr.) in foreground.

Photo taken from River Landing Road

just north of warehouse, looking south with Choptank River in background.

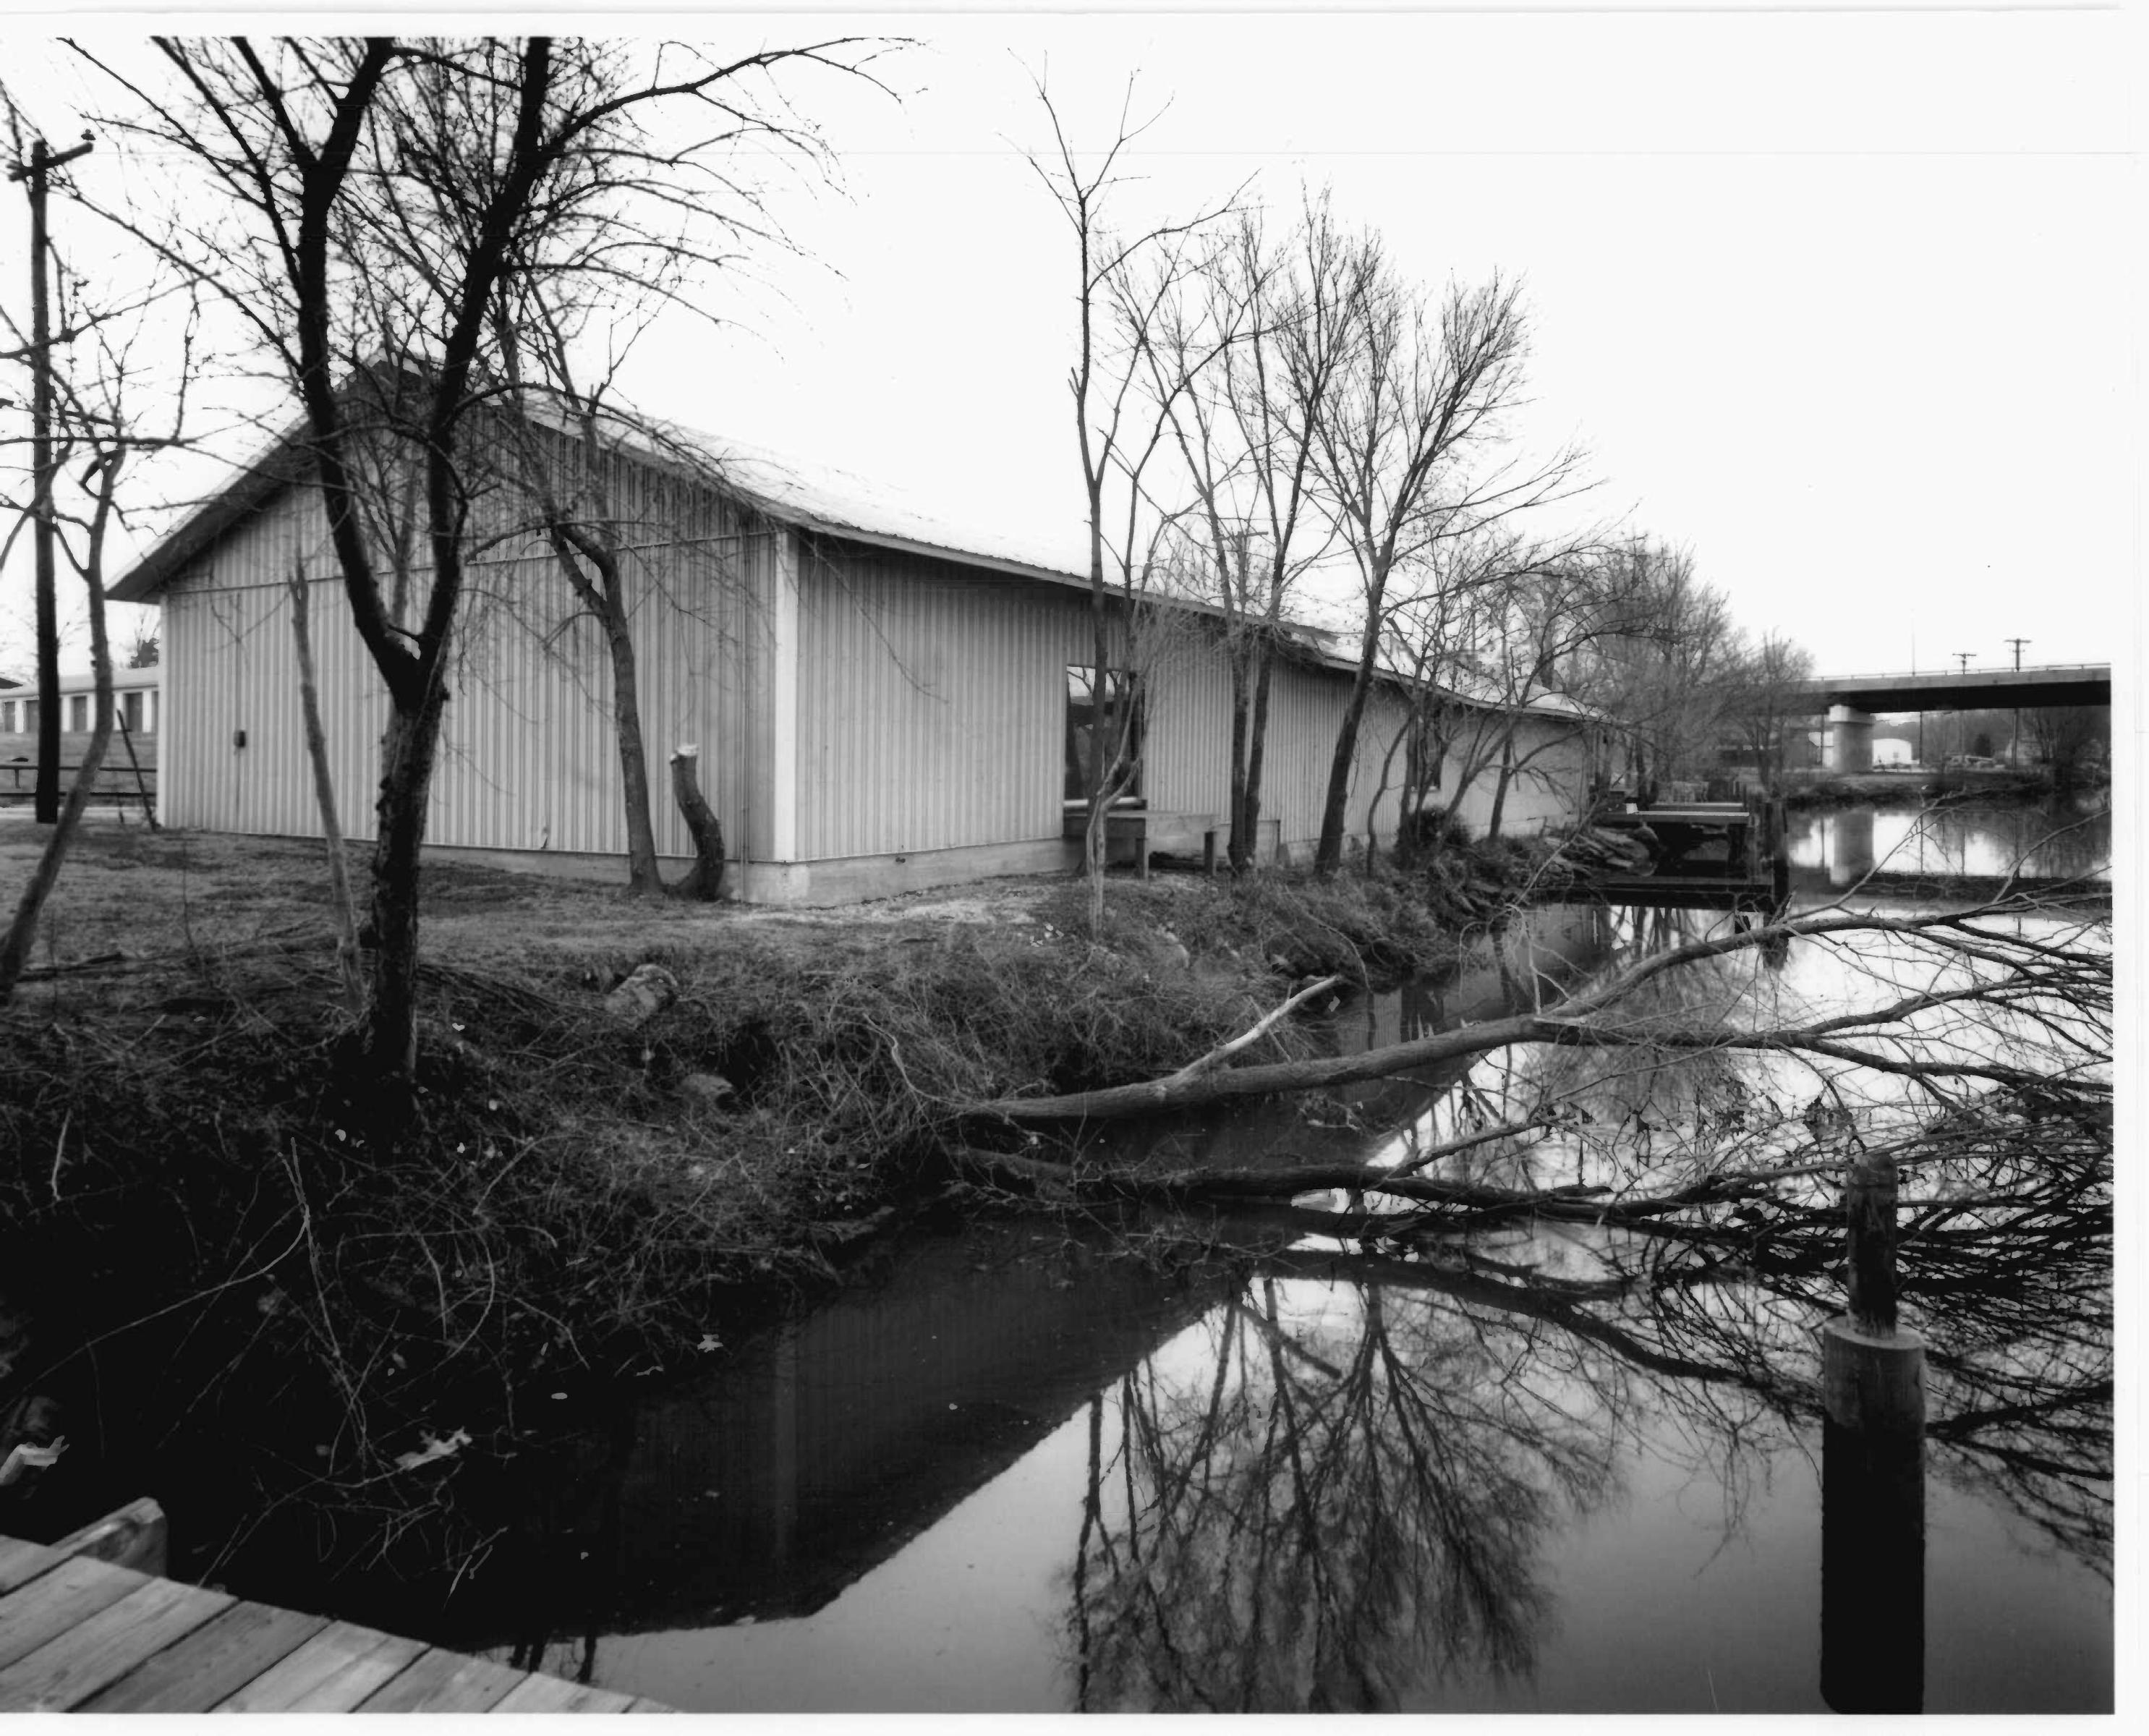
Description - South elevation (partial east elevation) of warehouse and frontage along Choptank River. Photo taken from wharf on south end of property facing north and upriver Wthe Md. Rt. 404 Business Bridge in the rt-hand side background.

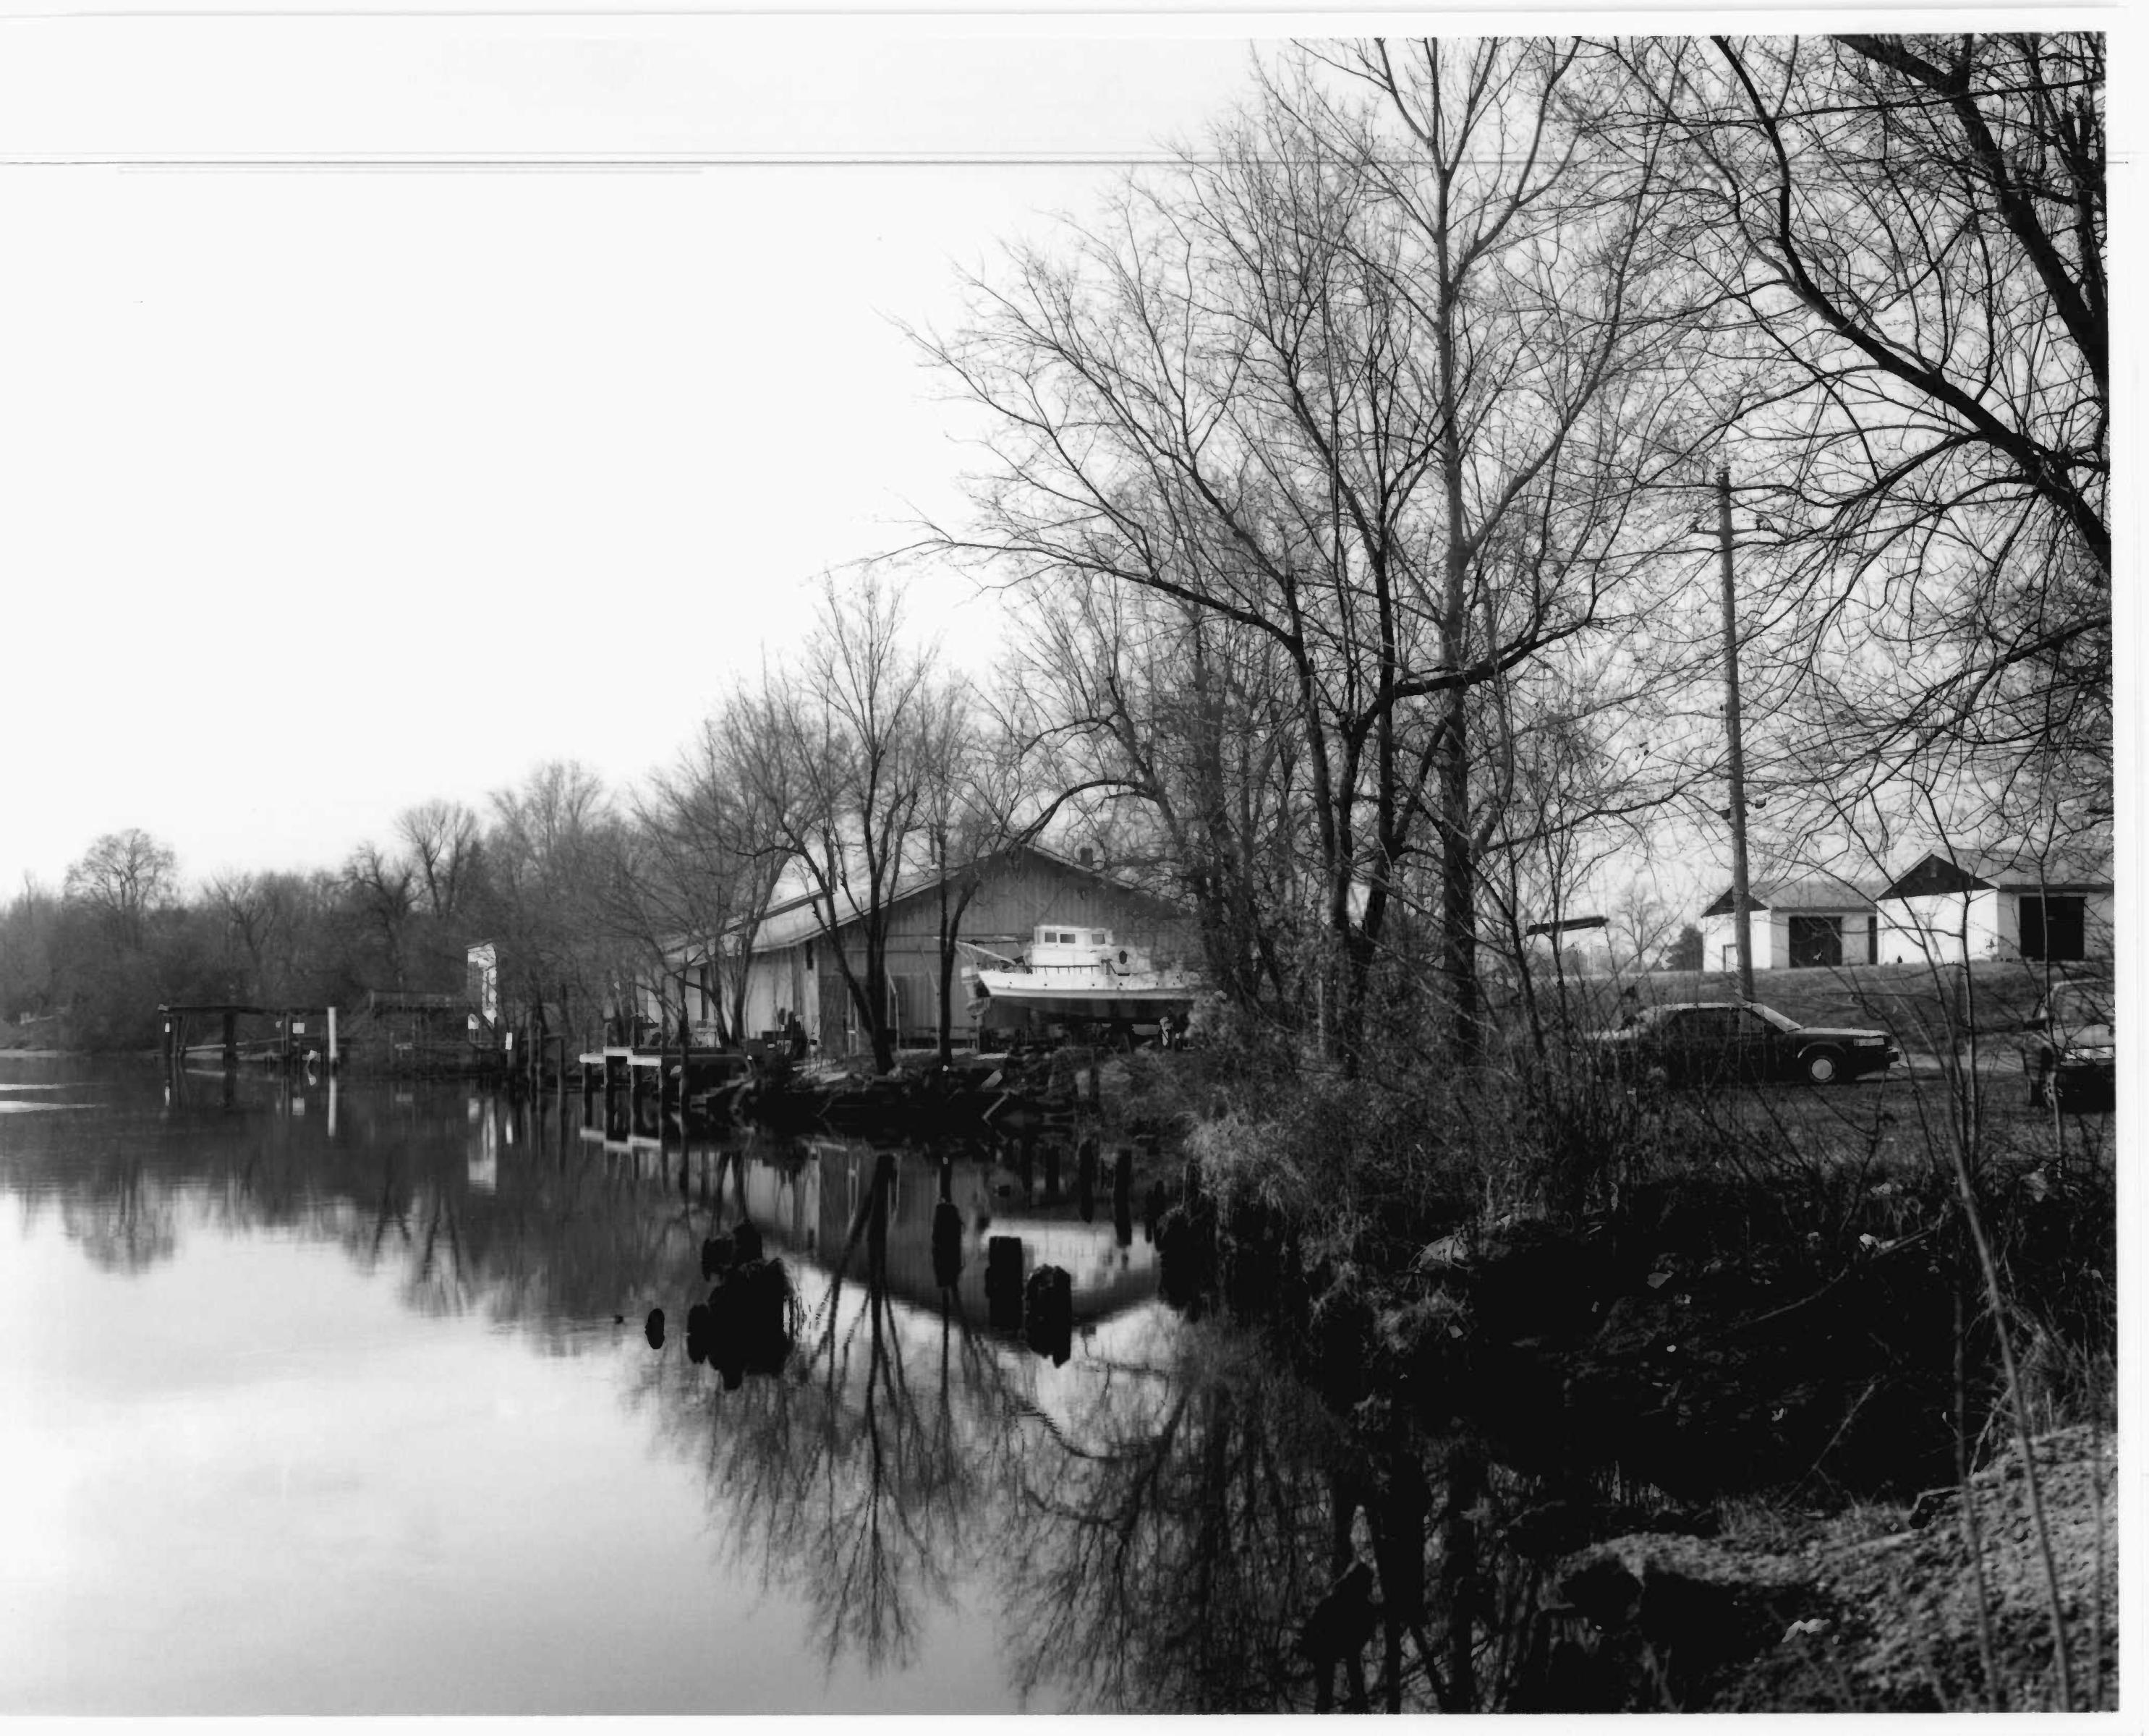
Description- Shoreline view along Choptank River

on-Shoreline view along Choptank River Wremnants of wharf piling in foreground. Photo taken from under the Md. Rt. 404 Rus. Bridge looking south (down river) W/ the wavehouse and skipjack (r.c. Lewis, Jr.) in the ctr. of the Photo.

Wharf: The warehouse had direct access to the Choptank River via bulkheads and wharves that run along its entire frontage. The wharf and bulkhead construction. consisted of oak piling, horizontal lagging for the bulkhead and timber planking for the wharf decking. Most of the bulkhead lagging has deteriorated but the pilings remain intact below the waterline.
